Follow-up to the meeting on 27 February 2012 “Breakdown of Ngong Ping 360 ropeway occurring in December 2011 and January 2012”

Ngong Ping 360 Ropeway
Incident occurred on 25 January 2012
Report of Investigation

Electrical and Mechanical Services Department
3 April 2012

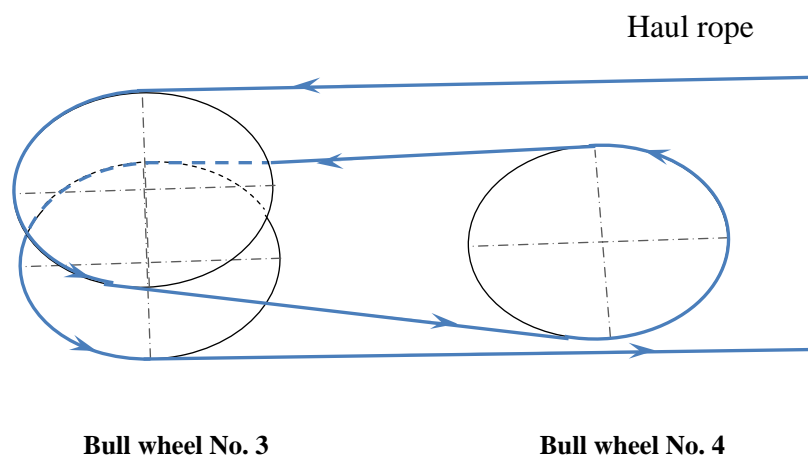
Figure 3 : Haul rope winding between the bull wheel No. 3 and bull wheel No. 4

5.6 According to the statements provided by the Competent Person, vigorous vibration of the haul rope between bull wheels No. 3 and No. 4 (see configuration of the haul rope at Figure 3) was observed along with the abnormal noise before triggering of the position sensor of bull wheel No. 4. The triggering of the position sensor was attributed to the vigorous vibration of the bull wheel No. 4.

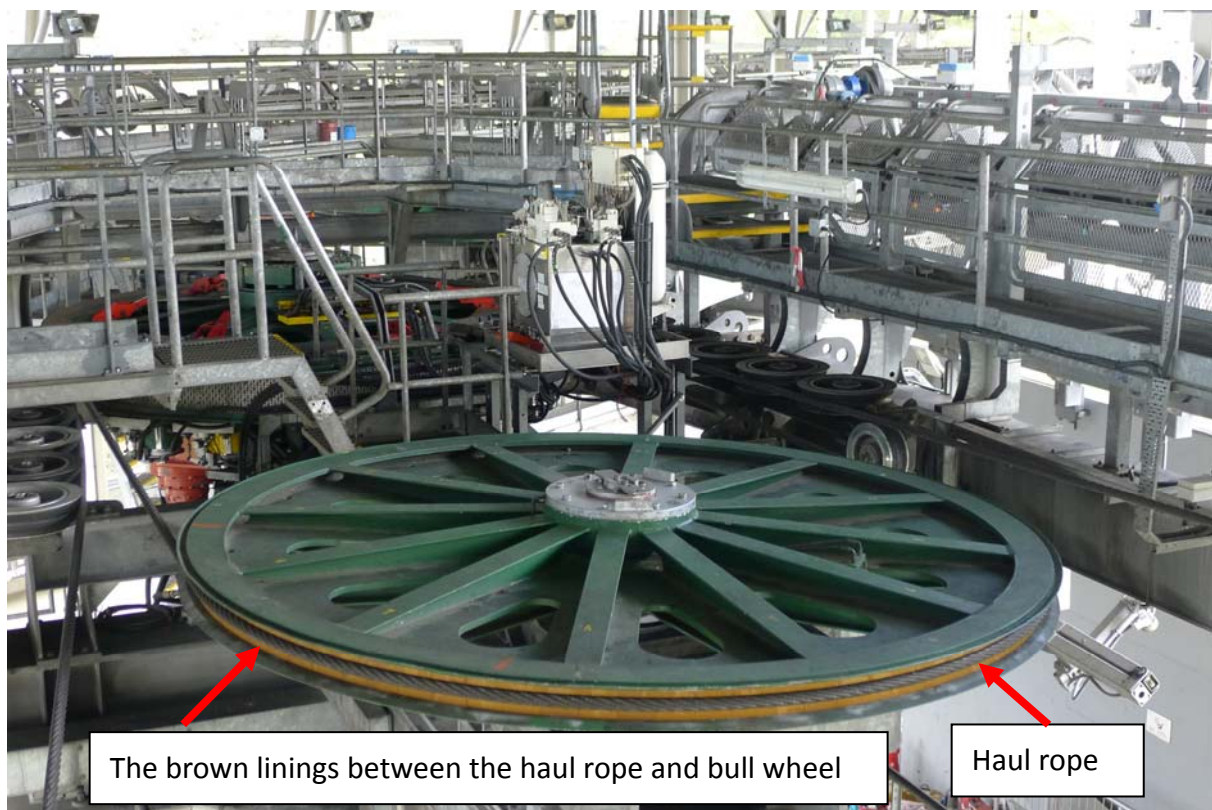
Figure 4 : Haul rope winding around the linings of the bull wheel No. 4

5.9 The on-site measurement of the lining (plastic) of the bull wheel No. 4 after the incident showed that about 45% of the lining (39 out of 87 lining units) already exceeded the wear limit. Uneven worn out of the lining was found.

and resulted in the unsmooth rotation of the bull wheel. This unsmooth rotation would lead to intermittent stretching and releasing of the haul rope which caused the uneven worn out of the lining and out-of-roundness of the bull wheel. Subsequently, vibration was induced to the haul rope and thus the bull wheel.

5.11 The measurement record of Ngong Ping 360 was checked and it was noted that the last routine measurement of the lining was conducted on 23 January 2012, i.e. 2 days before the incident. There were 3 out of a total of 12 measurement points marginally exceeding the wear limit. According to the established practice, Ngong Ping 360 had arranged the replacement of the lining but the replacement was yet to be done before the occurrence of the incident on 25 January 2012. The findings suggest that there might be abnormal accelerated wearing of the lining during the 3 days' operation from 23 to 25 January 2012 due to the spalled bearing operation, or the lining measurement conducted on 23 January might not be a thorough and accurate measurement. The findings also reveal that Ngong Ping 360 should enhance their lining replacement arrangement and replace the worn out lining as early as possible upon noticing any excessive wear from the routine measurement.

- (vi) The procedures and equipment for the measurement of all bull wheel linings, including the extent of wear and ovality (roundness) along the lining surface, have been reinforced and clearly specified, so as to ensure more timely identification and early remedial actions.

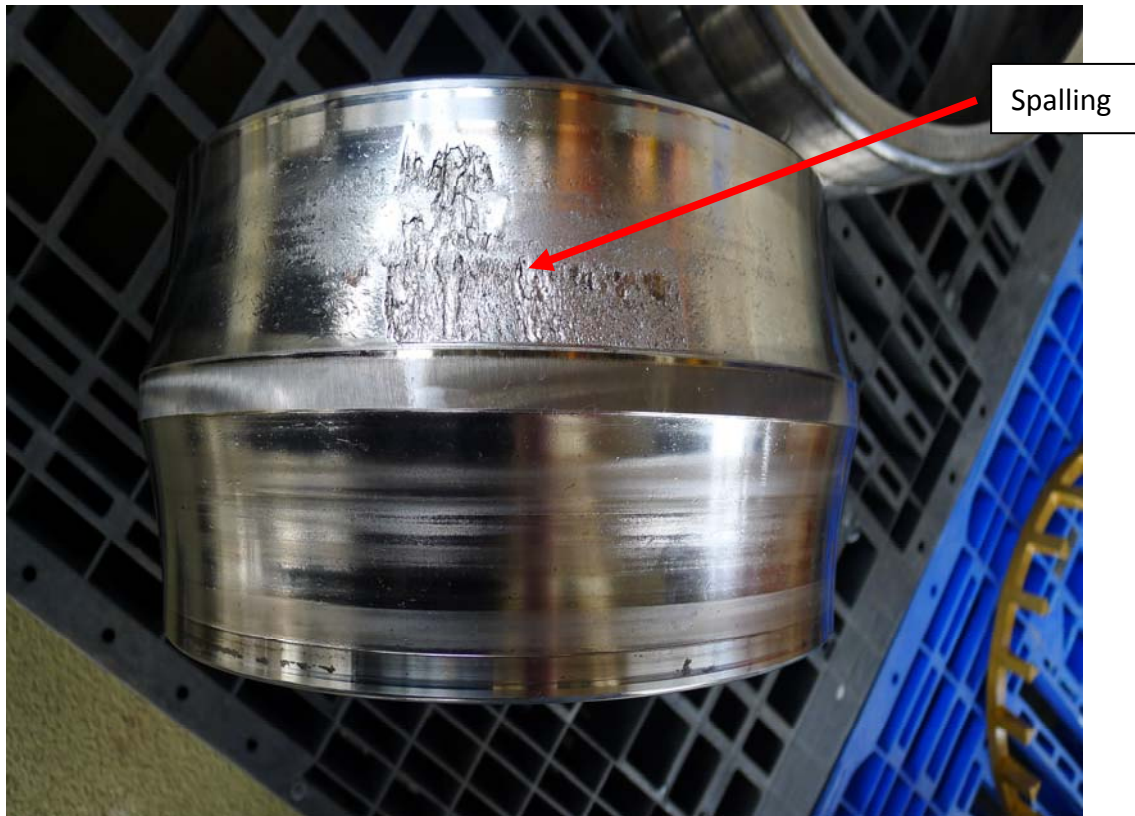
- (i) The spalling only occurred in the upper bearing ;
- (ii) For the inner ring of the upper bearing, brown staining from corrosion was found at the bottom raceway at the low loaded side (see Figure 6) while heavy spalling was found at the top raceway at the high loaded side (see Figure 5) ;
- (iii) In addition to spalling, heavy denting was found on the upper rollers of the upper bearing, as might be expected with the spalled metal fragments and the denting on the upper race (see Figure 7) ; and
- (iv) Corrosion/rust was also observed on the outer ring between the upper and lower rollers (see Figure 8).

Figure 5: Spalling in the top raceway of the inner ring of the upper bearing

5.16 As reflected from the result of the laboratory tests, it is considered that the spalling of the bearing was mainly caused by ineffective lubrication, arising from high moisture content in the grease leading to degraded lubricating effectiveness. The iron oxide particles in the grease might further degrade the lubricating effect of the grease and accelerate the spalling of the bearing.

- (i) All the bull wheel bearings should be replaced because they all may be subject to the same unsatisfactory greasing condition, which may lead to potential bearing spalling at a later stage.
- (ii) Vibration monitoring system of all the bull wheel bearings should be upgraded to capture the vibration data in an on-going basis, while the collected data should be analysed in a more frequent interval (every 2 weeks) against the pre-warning level.
- (iii) Grease analysis should be performed monthly to closely monitor the moisture and metal content of the grease, so as to step up the regreasing interval/frequency according to the analysis result.
- (iv) Arrangement shall be made to properly store and handle the grease to be

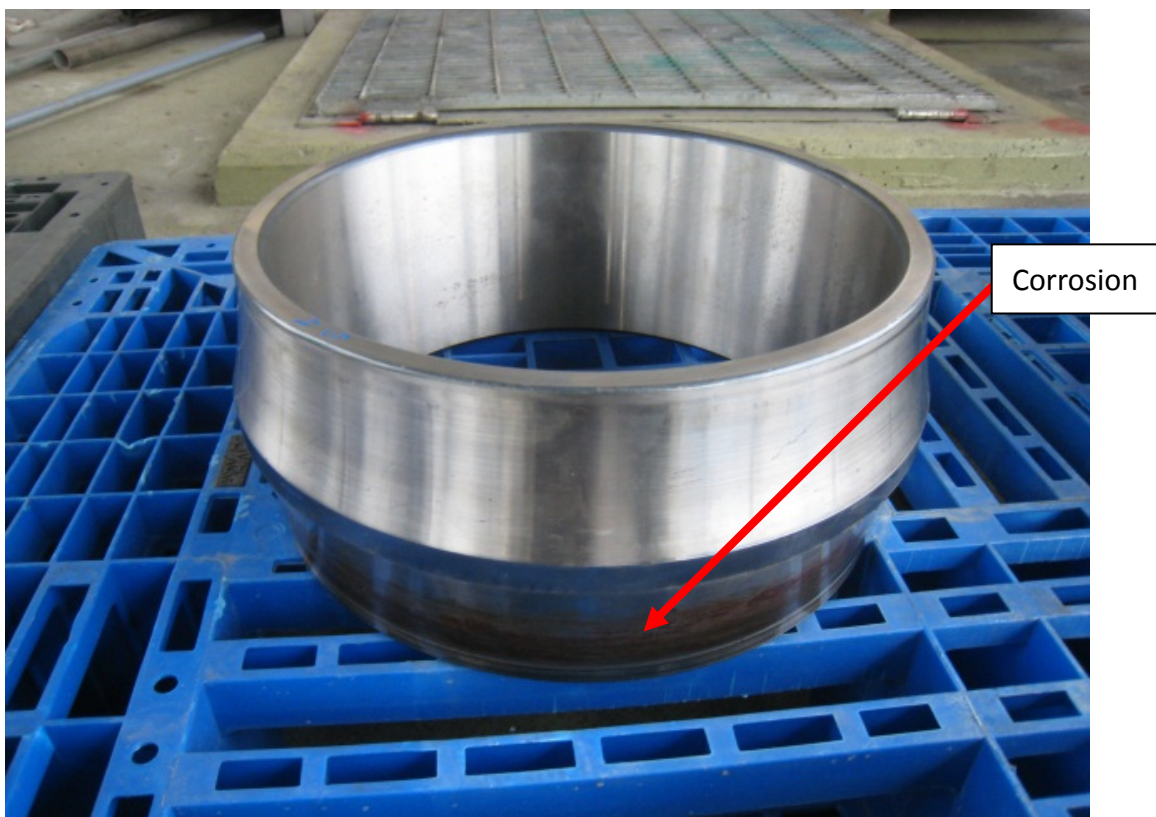
Figure 6: Corrosion in the bottom raceway of the inner ring of the upper bearing

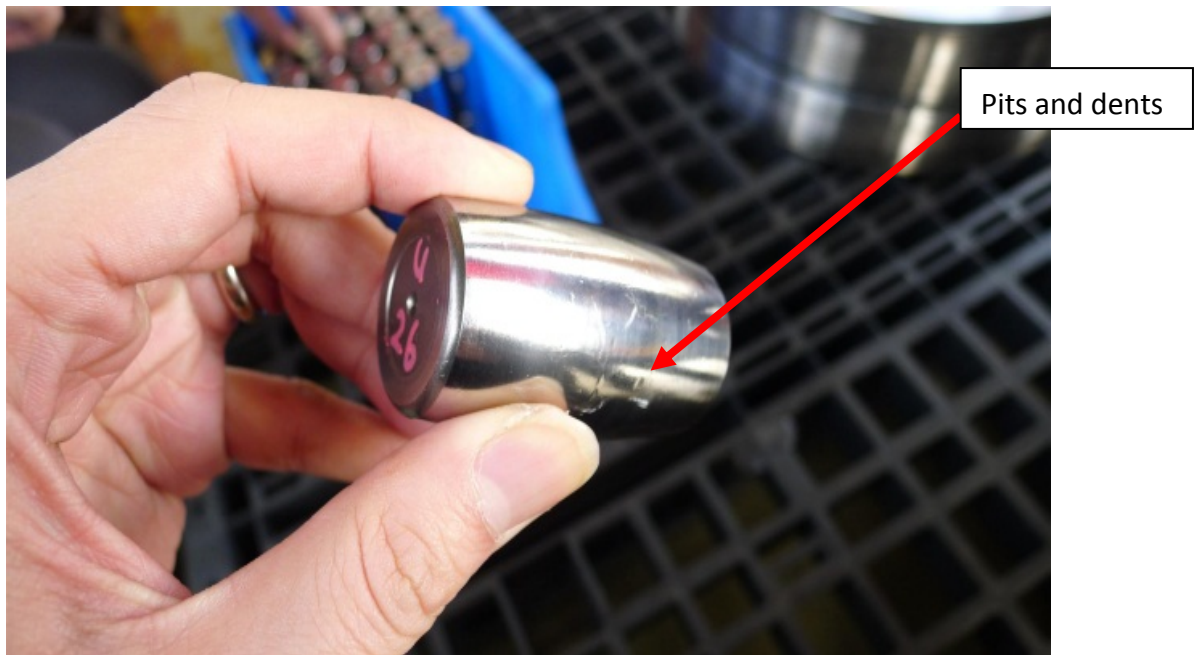
Figure 7: Pits and dents on rolling element from the top row of the upper bearing

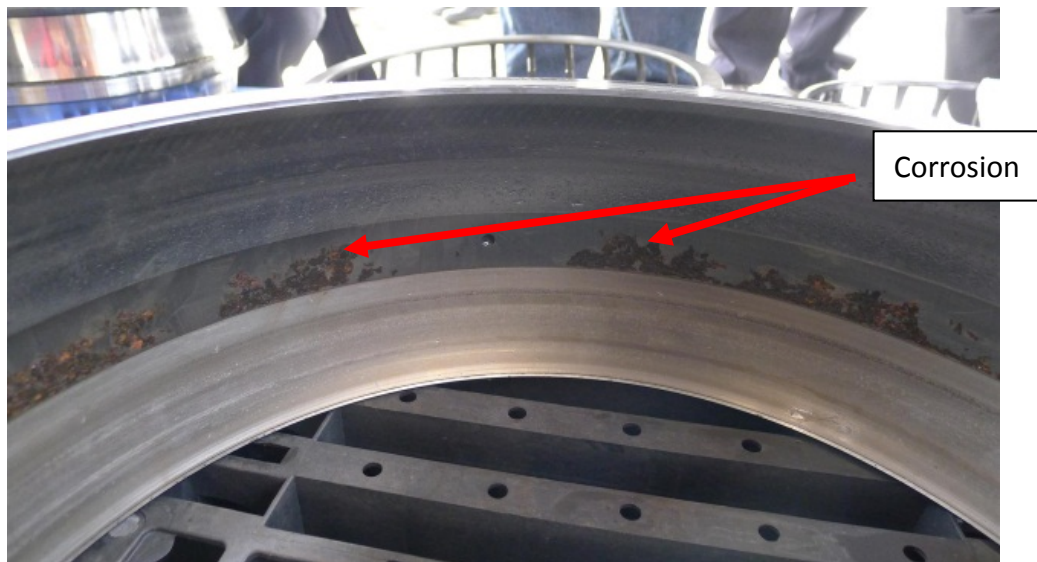
Figure 8: Corrosion in the outer ring of the upper bearing
