Follow-up to the meeting on 27 February 2012 “Breakdown of Ngong Ping 360 ropeway occurring in December 2011 and January 2012”

Ngong Ping 360 Ropeway
Incident occurred on 25 January 2012
Report of Investigation

Electrical and Mechanical Services Department
3 April 2012

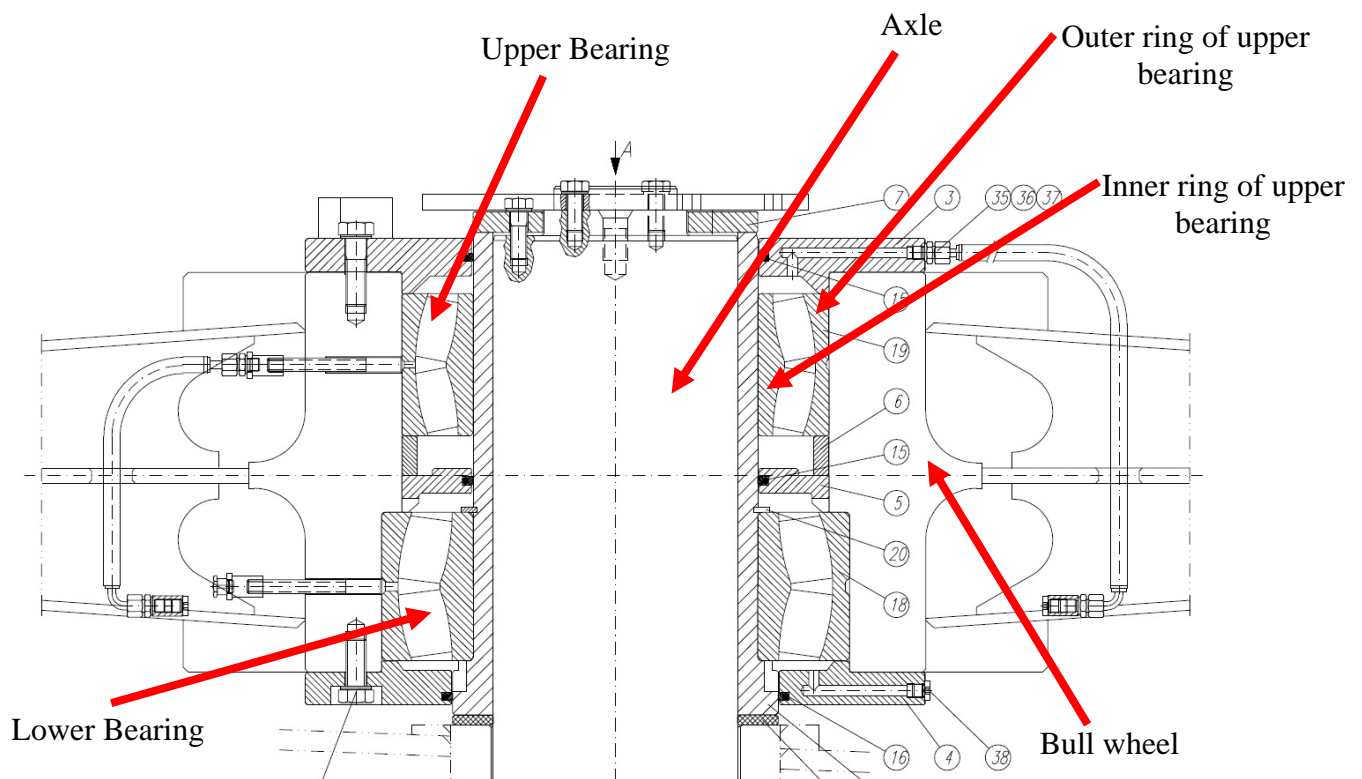
used to drive and guide the haul ropes in Section I and Section II. Two bearings (upper and lower) (see Figure 1) are used in each bull wheel to connect the bull wheel to its shaft. Among the numerous protective devices (more than 1,000) installed to ensure safe operation of the Ropeway, position sensor is installed adjacent to each bull wheel to stop the ropeway operation when there is any abnormal vibration in any of the bull wheels. A schematic diagram of the Ropeway is given in Figure 2 below.

Figure 1 : Configuration of a typical bull wheel of the Ngong Ping 360 Ropeway

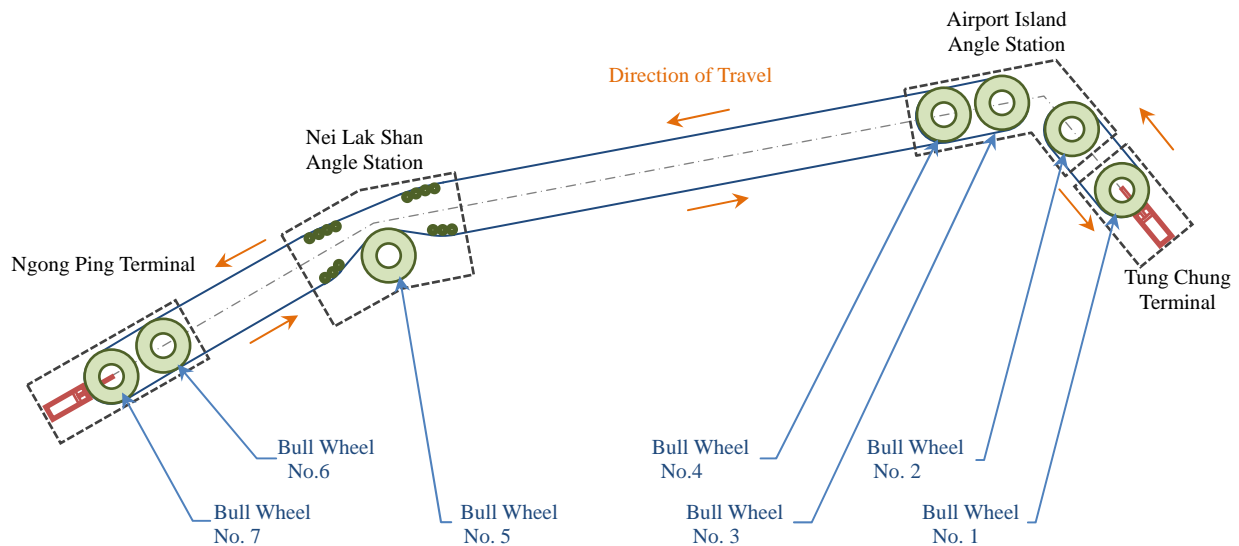
Figure 2 : Schematic diagram of the Ngong Ping 360 Ropeway
